Manhole Inspection Summary

Manhole # S29E__006MH

Insp Date: **9/25/08 10:26 AM**

Location Address: **663 Vine St**

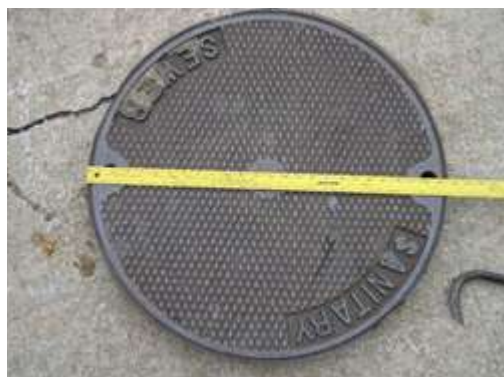
Cover View

Condition: **Sound**

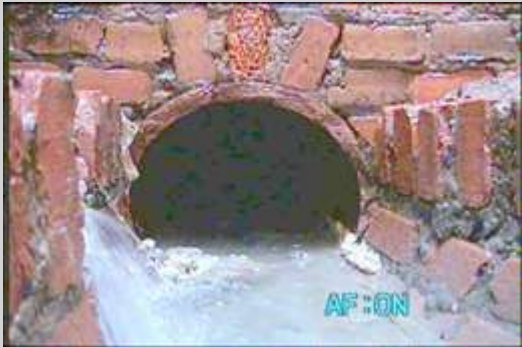
12 O'Clock Outflow

12 in. Circular Gravity Sewer
Pipe Out @ 12 O'Clock

Pipe Height: **12** (in.) Rod and Bar (Angled)
Pipe Material: **Clay** ☐ Pipe Lined
Invert Depth: **9.41** (ft.) Flow Characteristics: **Slow**
Deposits: ☒ None ☐ Mud ☐ Sludge ☐ Debris ☐ Grease
Silt Depth: **0** (in.) Deposits Extent:
Infiltration: **None** Pipe Seal Cond: **Sound**

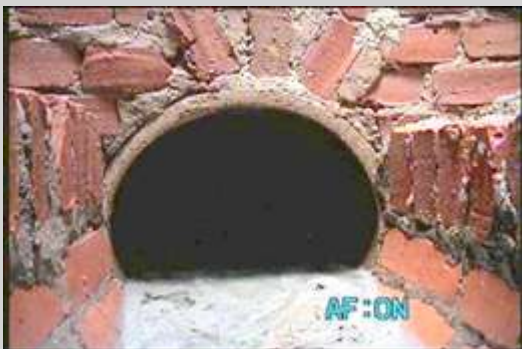
5 O'Clock Inflow

10 in. Circular Gravity Sewer
Pipe In @ 5 O'Clock

Pipe Height: **10.8** (in.) Rod and Bar (Angled)
Pipe Material: **Clay** ☐ Pipe Lined
Invert Depth: **9.18** (ft.) Flow Characteristics: **Slow**
Deposits: ☒ None ☐ Mud ☐ Sludge ☐ Debris ☐ Grease
Silt Depth: **0** (in.) Deposits Extent:
Infiltration: **None** Pipe Seal Cond: **Sound**

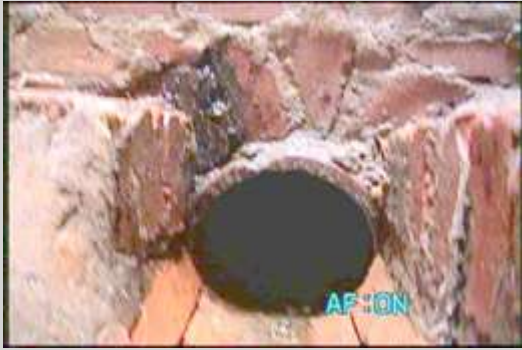
6 O'Clock Inflow

6 in. Circular Gravity Sewer

Pipe In @ 6 O'Clock

Pipe Height: **6** (in.) Rod and Bar (Angled)

Pipe Material: **Clay** ☐ Pipe Lined

Infiltration: **None** Pipe Seal Cond: **Sound**
